ARMY TRAINING SUPPORT CENTER, PHASE I

Poor Facility Conditions Impact Mission Execution

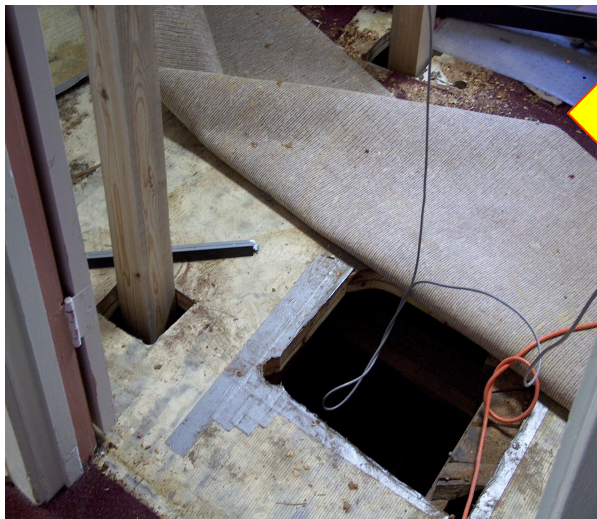
2004

Condemned

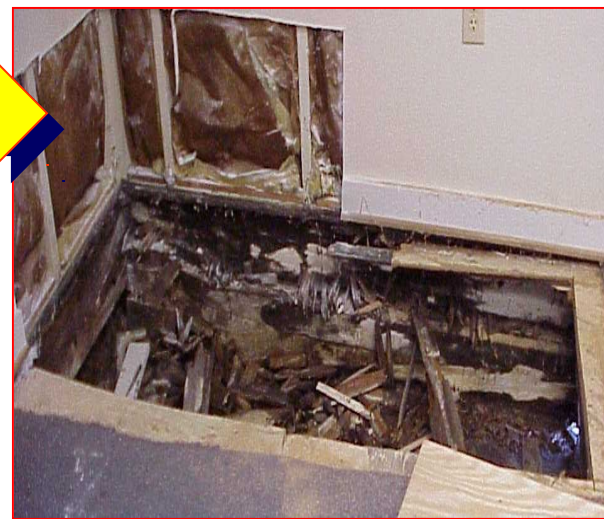
2006- Post Safety & DPW ordered evacuation of B-1549 (Aug) due to floor structure problems.

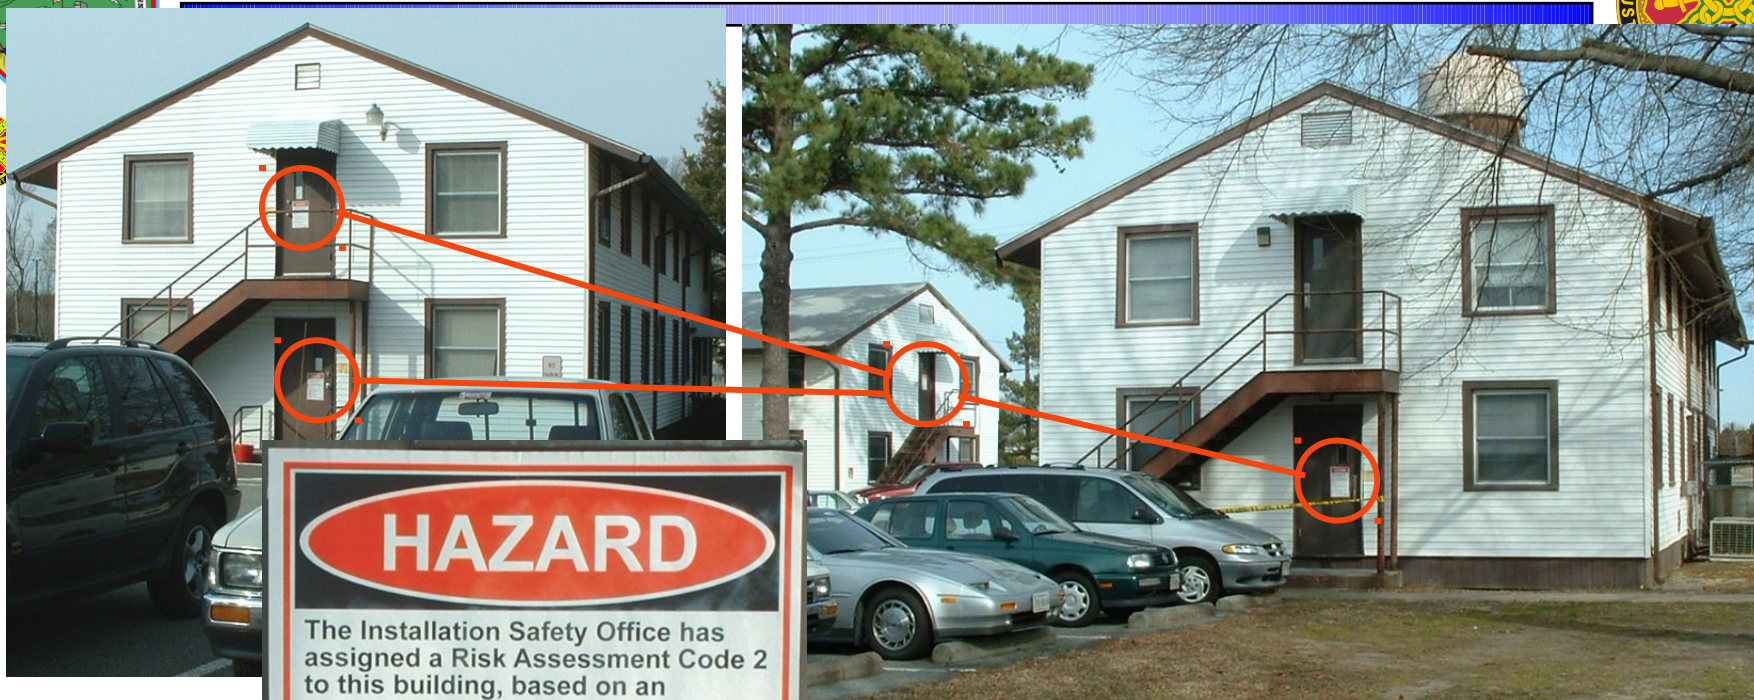
HAZARD

The Installation Safety Office has assigned a Risk Assessment Code 2 to this building, based on an engineering report of potential structural deficiencies.

Until adequate replacement facilities are made available, the following Interim Control Procedures should be followed:

- Remove heavy items from the second floor
- Restrict access to the second floor, as much as possible
- Report any further deterioration of conditions

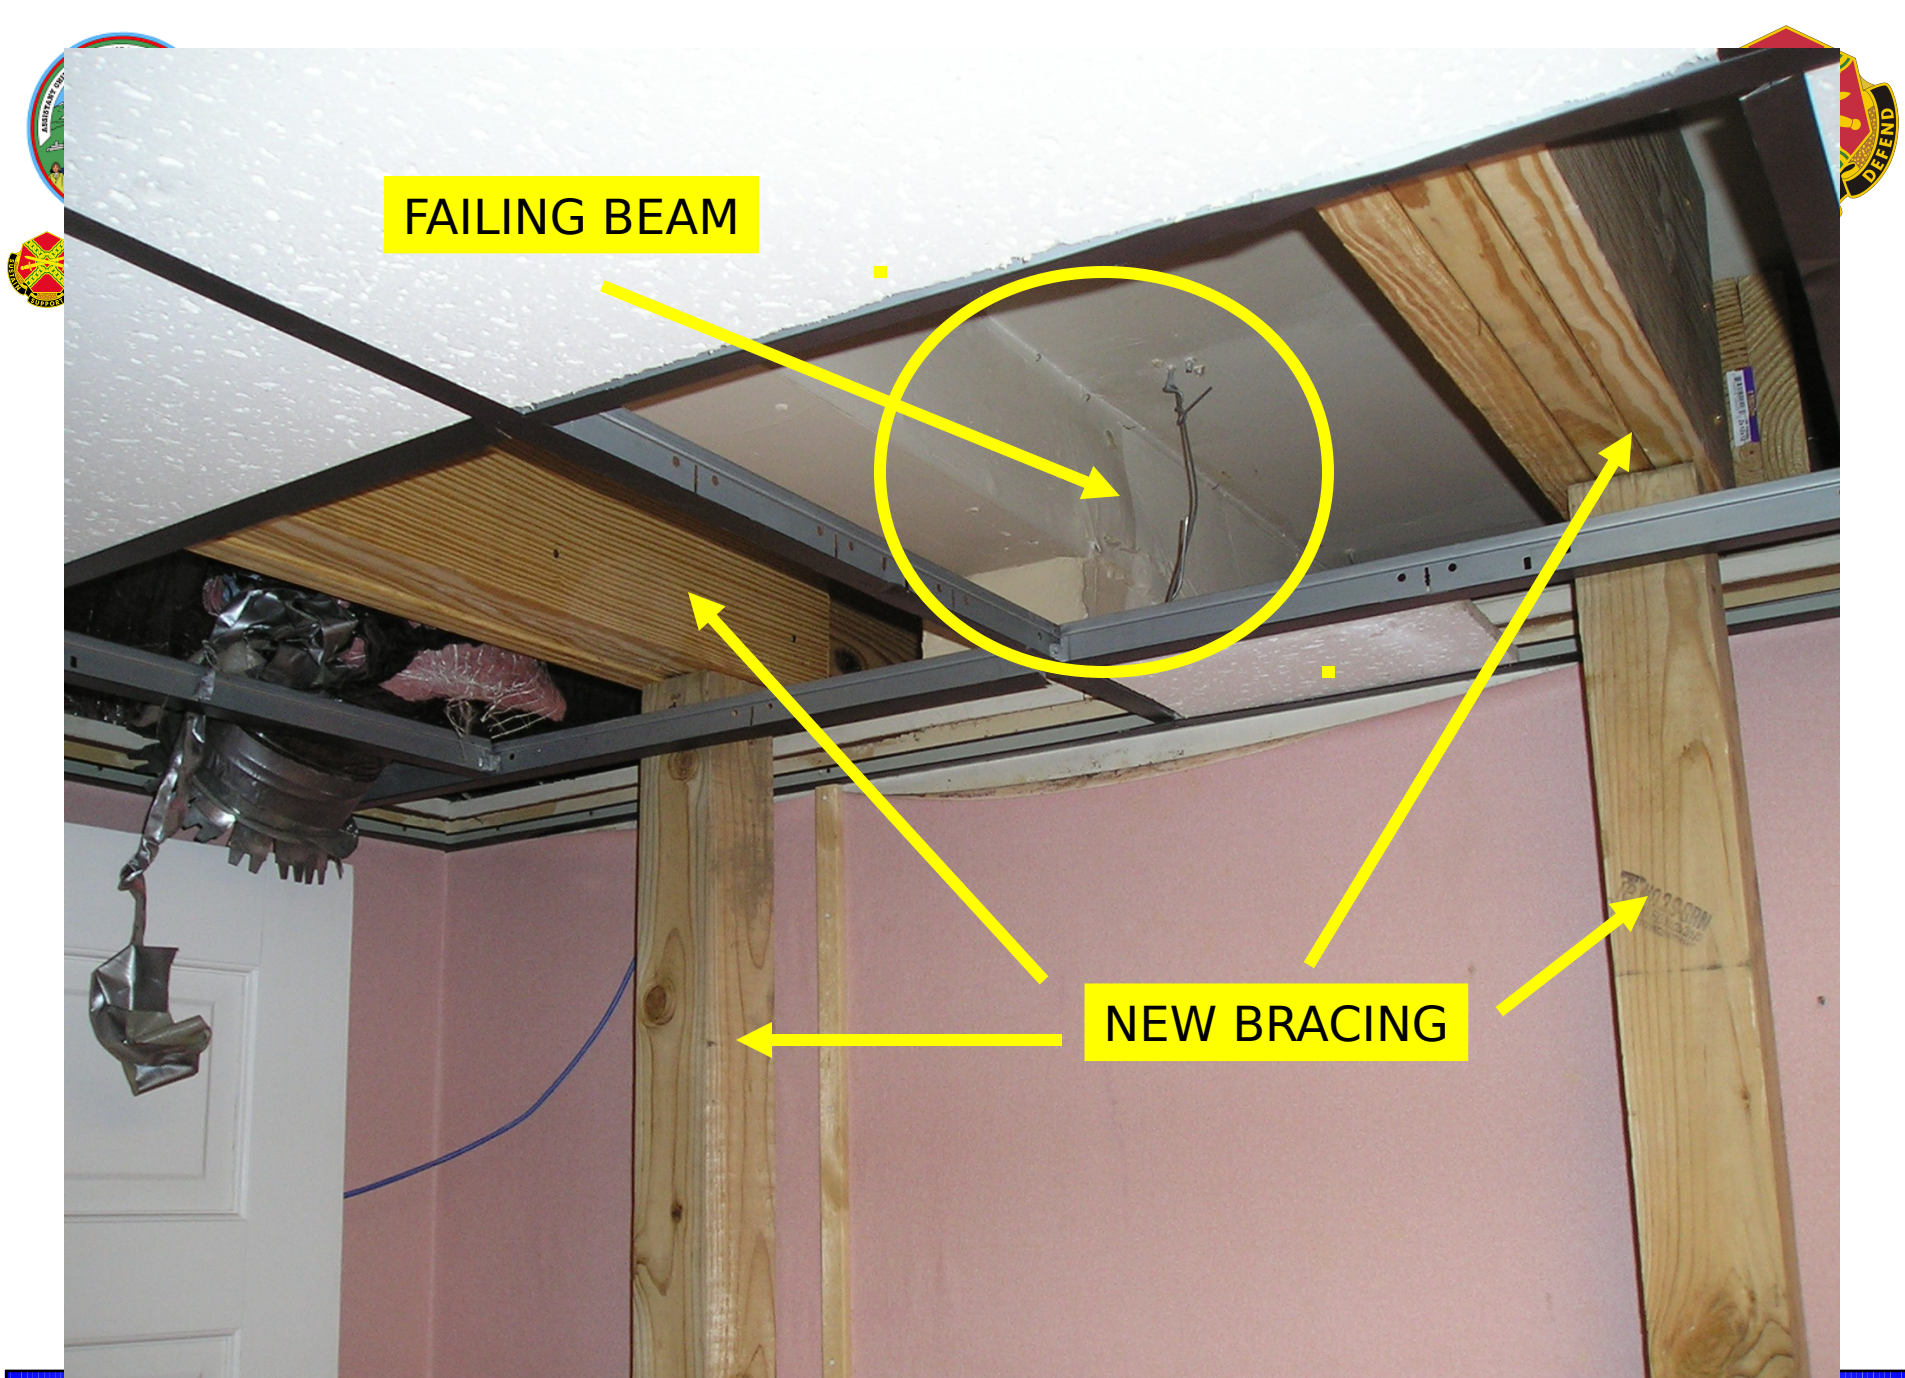
FAILING BEAM

NEW BRACING
